# Home Inspection Report

**1234 Street Ave.**

**Inspection Date:** February 13, 2008  
**Report Date:** February 13, 2008  
**Weather Conditions:** overcast  
**Temperature:** 75 degrees  
**Present During Inspection:** seller, buyer, buyers agent  
**Building Occupied:** yes occupied  
**Inspection Excludes:** exterior storage shed  
**Inspection Includes:** the pool

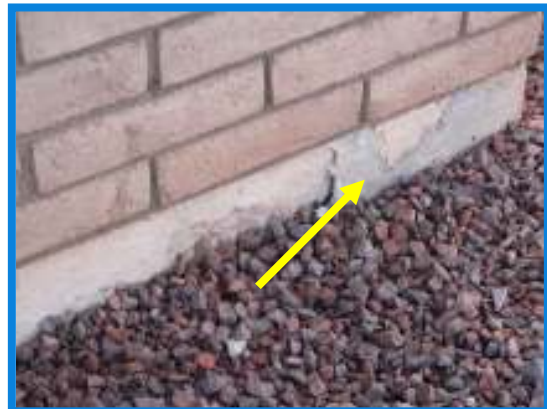
There is minor stemwall spawling at the northwest corner of house. It does not appear to be active at this time. Recommend monitoring.

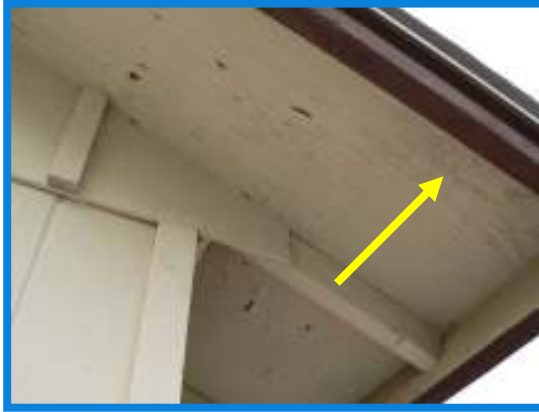
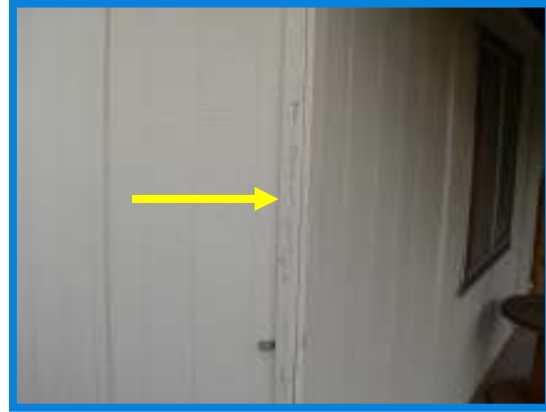
Portions of the exterior woodwork and painted surfaces are showing deterioration to the paint/stain finish. It is important that these surfaces are kept well protected to ensure a maximum service life. The need for exterior painting is now indicated. Subsequent paint maintenance can be carried out as the usual signs of failure such as cracking, peeling or blistering of the painted surface become evident. Typically this would occur at intervals of five to seven years.

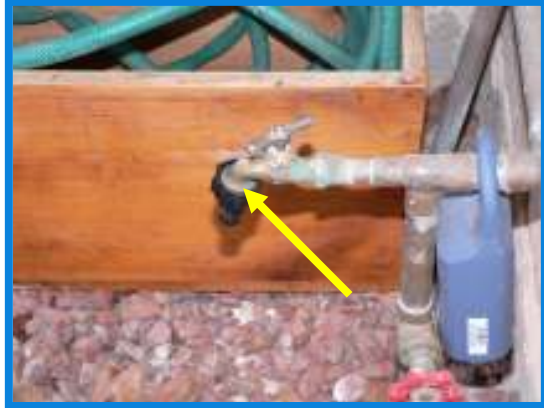
There is no anti-siphon valve (as required) where the lawn watering system ties into the main potable water supply. This condition could lead to contamination of the home water supply by allowing water from the sprinkler system to back up into the home. Recommendation: Installation of a proper anti-siphon valve by a licensed plumbing contractor.

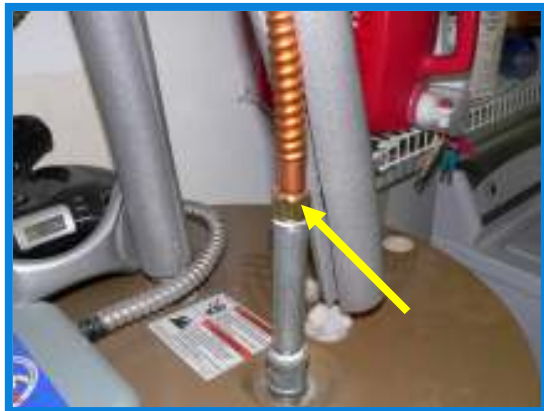
There are plumbing components of copper and steel that are in direct contact with each other. This will sometimes cause a chemical response known as 'galvanic reaction' that accelerates deterioration of the components involved and results in leaks. Such response is normally avoided with the use of either brass or dielectric (non-conductive) fittings between pipes of dissimilar metal. The affected components need to be replaced with those of compatible material or brass or dielectric fittings need to be installed to prevent galvanic reaction.

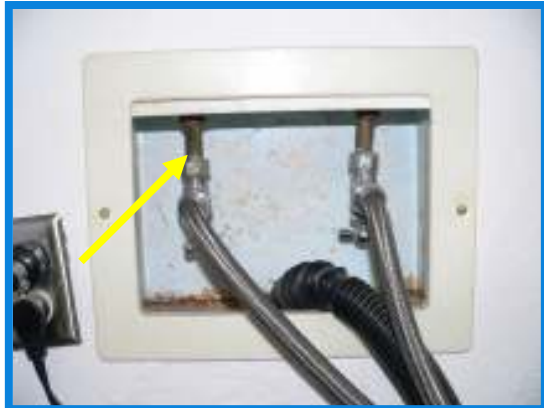
There is some minor corrosion on the washer hot and cold water valves. Recommend having repaired as necessary by a licensed contractor.

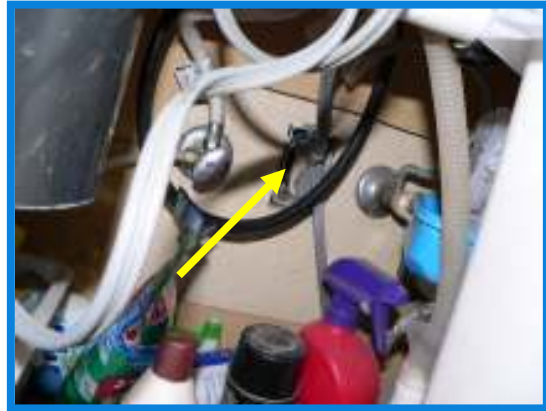
There are electrical outlet/s that are missing cover plates in the house. This is a safety issue due to exposed wires. Recommend replacing as necessary. Outlet under kitchen sink was noted missing cover plate.

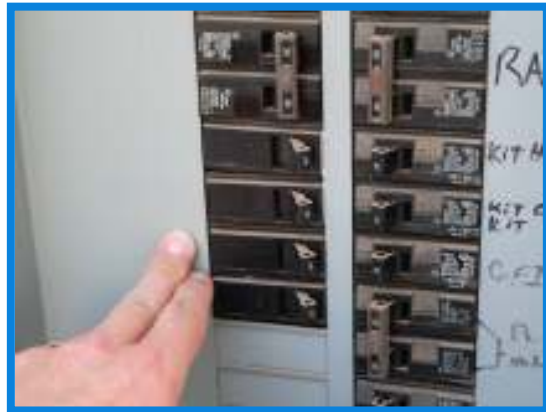
There are electrical lines that are improperly fed through a knockout on the pool sub panel. It is recommended to have a licensed contractor repair as necessary.

There are breakers in the main panel that aren't marked. In case of emergency it is difficult to know which breakers need turned off. Recommend labeling all breakers

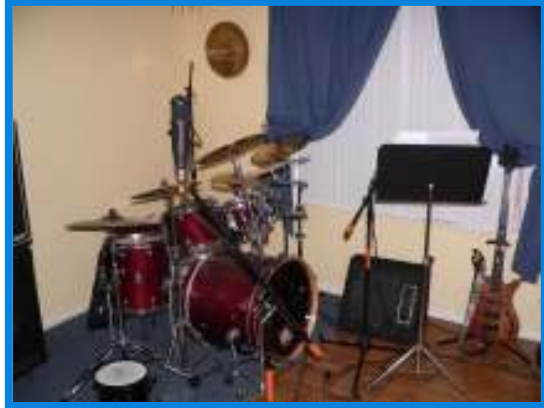
The left window in front room does not latch correctly. The right side lock will not lock. Left side locks fine. Recommend having repaired by a licensed contractor.

The left window in front room does not latch correctly. The right side lock will not lock. Left side locks fine. Recommend having repaired by a licensed contractor.

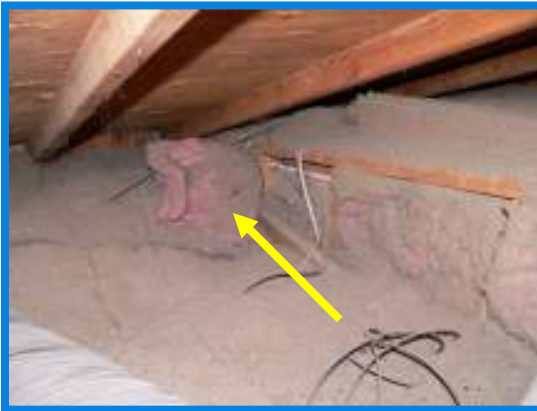
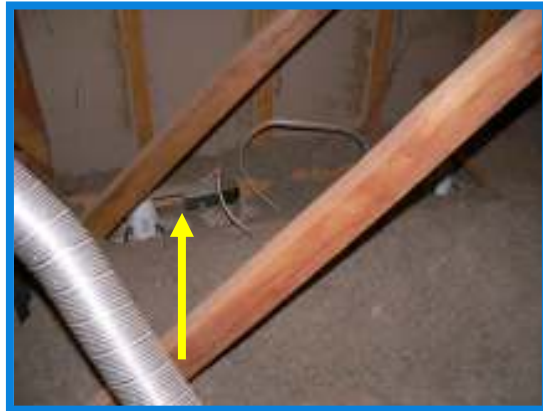
The blown in insulation has settled over time. This is typical for a house this age. Recommend having a licensed contractor evaluate and add insulation if necessary.

The attic insulation levels in this attic are inconsistent. This will result in uneven energy loss and comfort levels in the home. It is recommended that the insulation be redistributed and improved as necessary to ensure consistent comfort levels throughout the home.

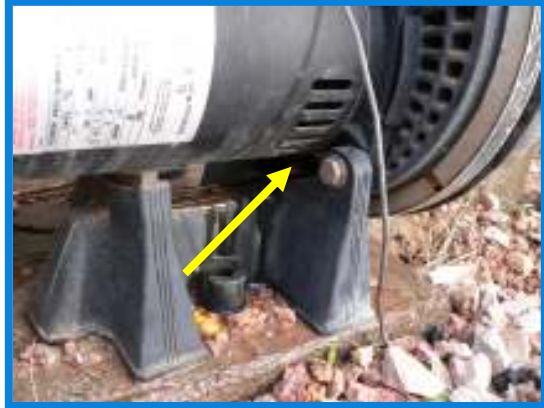
The pool equipment showed signs of a current water leak between the pump housing and pump. Recommend having repaired by a licensed contractor.

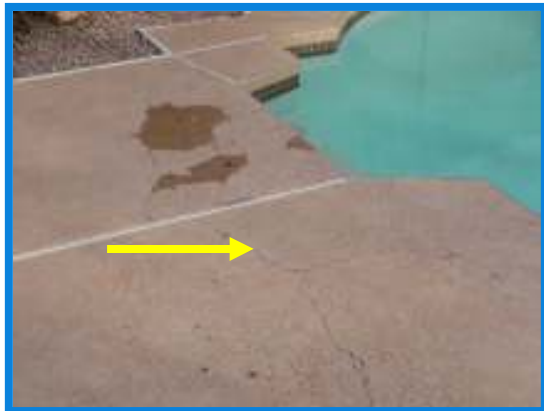
The pool decking has several settling cracks around the perimeter of pool. None seem to be currently active. Recommend having repaired by a licensed contractor.

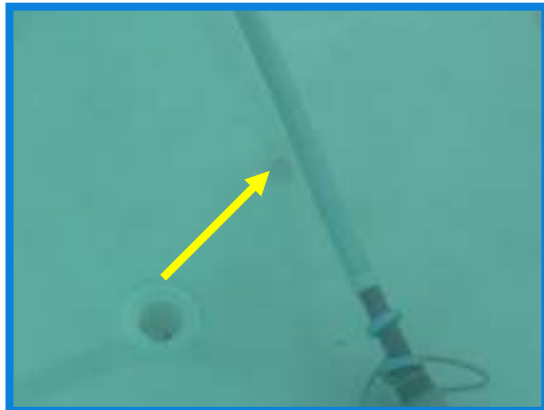
The plaster pool finish has a few chips and cracks in the surface. Recommend having a licensed contractor evaluate/repair as necessary.
